Mandatory Service Bulletin

ENGINE COMPONENTS, INC.

M.S.B. No.: 04-1

Title: MANDATORY CYLINDER INSPECTION

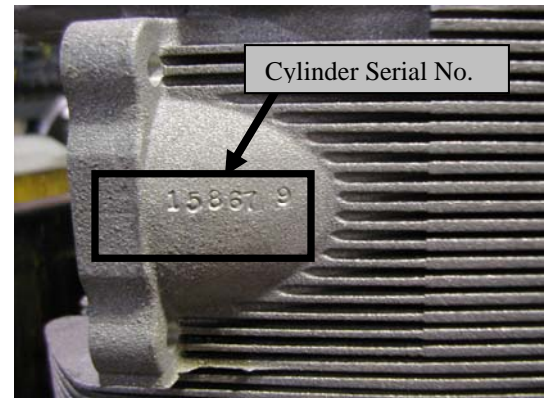
Photograph 1

- a. Determine that the engine is an IO/TSIO-520 or IO-550 engine and that the cylinder serial numbers are below 7709. The cylinder serial numbers can be determined by checking the engine overhaul/repair documentation, or by visually verifying the serial numbers stamped on the outside of the intake port boss (Photograph 1). If the cylinder serial number is 7709 or above, this bulletin does not apply.
- b. Remove the rocker box covers from the cylinders and determine if the cylinders are made from ECi casting Part No. AEC65385 as shown in Photograph 2. Verify that the cylinder head marking is identical to Photograph 2, with the part number between the ECi logo and the rocker box flange. Also, the letter "O" will be below the ECi logo as shown.

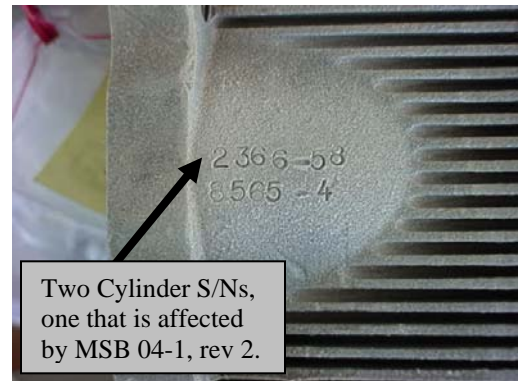
Photograph 3

- c. Note that some cylinders have two serial numbers. Both numbers may be on the outboard side of the intake port (as shown in Photograph 3), or there may be one at this location and one on the flat area below the intake port side adjacent to the head/barrel junction (see Photograph 4). If either serial number is below 7709 and markings identified in paragraph (b) are present, the cylinder may be affected. If the cylinder is stamped “A” as shown in Photograph 5 below, remove the cylinder and ship to ECi. **NOTE: This only applies if the cylinder has two S/N’s in addition to the letter “A”.** If the cylinder is stamped “B” in the same location, the cylinder is not affected.

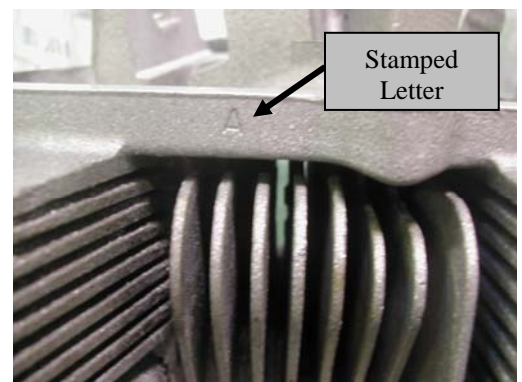
Photograph 5

- d. If the cylinder is identified as an ECi replacement cylinder with the identification shown, and has only one S/N, which is less than 7709, then view the rocker box flange from the top of the cylinder. Determine if there is the letter “A” or the letter “X” stamped on the rocker box flange as shown in Photograph 5. If the letter “A” or “X” is stamped on the rocker box flange, regardless of the serial number, then no further action is required. Record the inspection in the engine logbooks and return the airplane to service.

- h. Cylinders that do not meet the design requirements will be replaced. Engine Components, Inc. will reinstate the original limited warranty that came with the cylinders to the date ECi ships the cylinders back after the inspection has been completed. Cylinders that have been inspected by ECi will be identified with a letter “B” stamped in the area where “A” is stamped as shown in Photograph 5. Cylinders that are replaced will be marked with the letter “A.”
