SERVICE BULLETIN**SB25-03**

SUBJECT: Riveted V-Band Coupling, Part No. 670105
PURPOSE: Exhaust V-Band Coupling Rivet Inspection
COMPLIANCE: During 100-Hour/Annual Inspection or next engine/aircraft exhaust system maintenance event, whichever comes first
MODELS
AFFECTED: LTSIO-360-RB; TSIO-360-MB, RB, SB; TSIO-520-BE; TSIO-550-A, B, C, E, G, J, K, N; TSIOF-550-D, J & K engine models

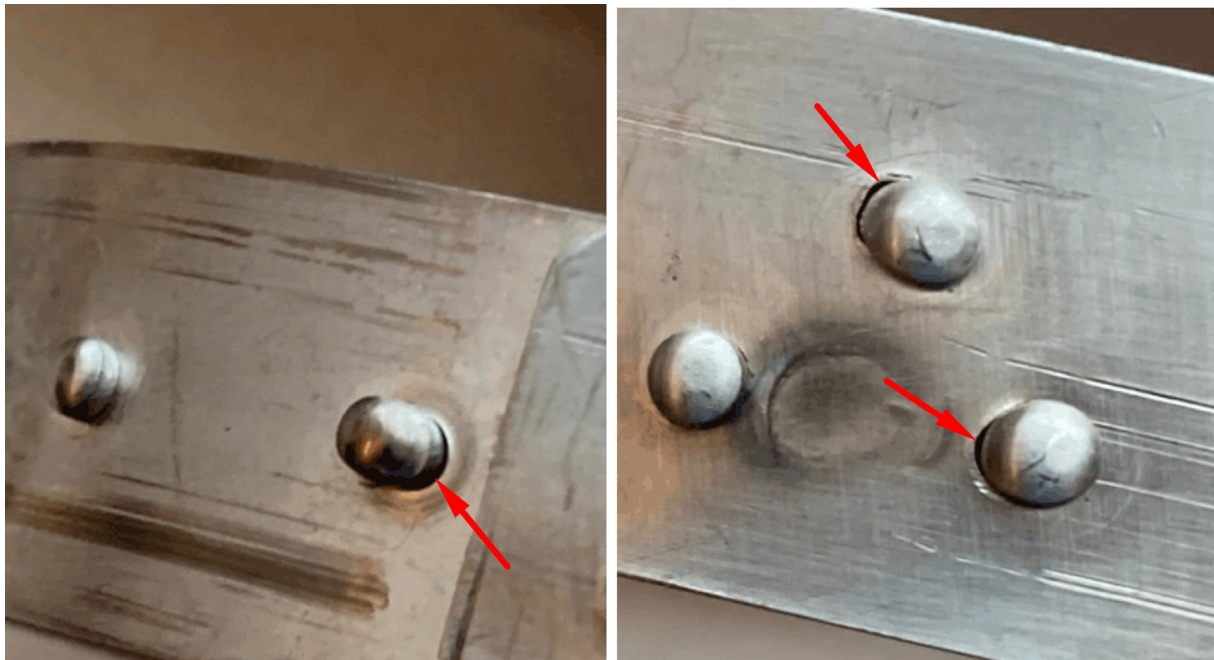
Continental has been notified some exhaust V-Band Coupling Part No. 670105 rivets may have been improperly formed during the manufacturing process. While the V-Band Couplings meet all functional requirements, the physical appearance of the rivets are not consistent with the industry standards for rivet installation (see amplified instructions in Section II.A). In Figure 1 below, the red arrows point to rivets that do not conform to industry standards.

Figure 1. Suspect Rivets Installed on Part No. 670105 Clamps

Perform turbocharger and exhaust system inspection according to the instructions in M-0, Standard Practice Maintenance Manual, Section 6-4.21. While performing specified inspections, inspect the affected Part No. 670105 V-Band Coupling condition after removal. If the V-Band Coupling(s) exhibit any of the characteristics depicted in Figure 3, replace the suspect V-Band couplings according to the instructions in the applicable engine model primary ICA (see ICA Part No. to engine model cross-reference in M-0, Section 1-1.1).

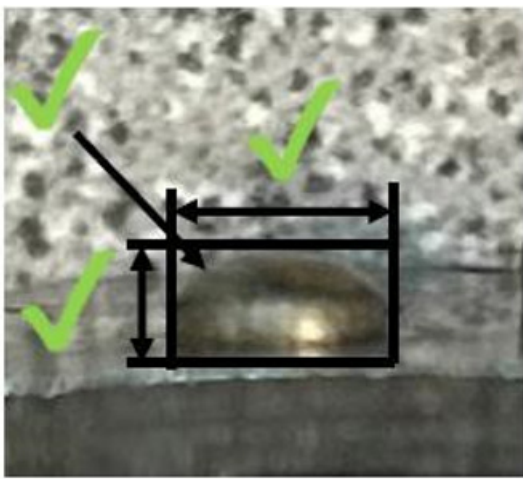
- Rivet Heads Exhibit a Distinct Mushroom Shape - Example A
- Rivet Conforms to the Shape Illustrated - Example A
- Rivet Head Shape is Consistent and Flush with Surface - Example A
- No Evident Material Damage Surrounding the Rivet Insertion Points - Example B

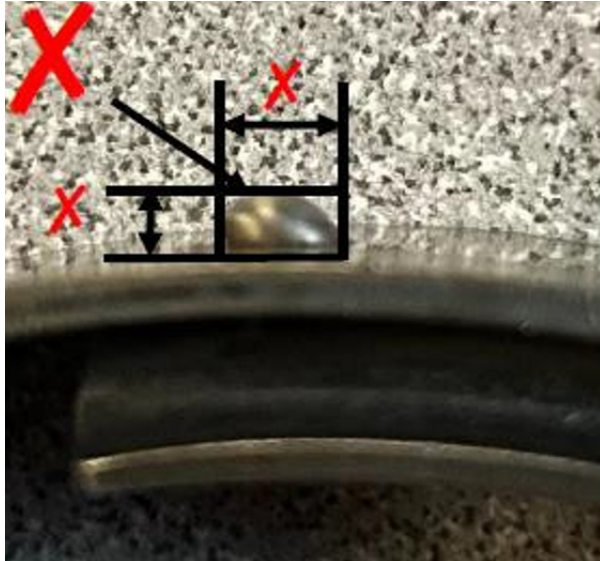
- Rivet Head Exhibits a Distorted Shape - Example C
- Rivet Head Shape is Inconsistent/Not Flush with Surface - Example D
- Evident Material Damage Surrounding the Rivet Insertion Points - Example E
- Visibility of Rivet Pre-Drill Hole - Example F
